Conservation of water distribution system for irrigation using restoration methods (A Case Study)

The present study is based on the case study of Pench Left Bank Canal of Nagpur district, Maharashtra state. Water supply to Nagpur city and irrigation in rural areas of district was severely affected due to numerous incidents involving breaches in Pench project canal. These breaches not only caused adherence in the irrigation but also lead to a fall in GDP. Moreover, these issues posed a risk of drought like situations in the states of Maharashtra and Madhya Pradesh. The Water Resource Department conducted a detailed study on these breaches and found out that the conventional methods of restoration and repair of these canals using CC lining caused more expenditure and required regular maintenance. The area under study has expansive soil and small change in moisture conditions affects the CC lining. A filling of cohesive non-swelling (CNS) soil like murum has to be laid and compacted to required density and then CC layer has to be placed. Despite taking care of the soil conditions, any micro movements in the sub strata, water levels, moisture conditions may cause cracking of the linin

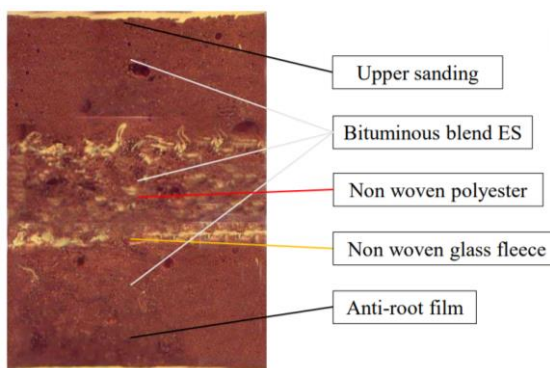
Bituminous Geomembrane or BGM is a composite material with layers of materials blended and joined together to achieve required results. Typically it consists of non-woven geotextile and glass fleece layers blended with elastomeric bitumen and sanded surface for friction

on one side and anti-root layer on other side. The geotextiles are responsible for mechanical properties and bituminous layer provides waterproofing and chemical resistance. BGM has following advantages over CC lining-

Fig. 3: Geotextile and bituminous blend

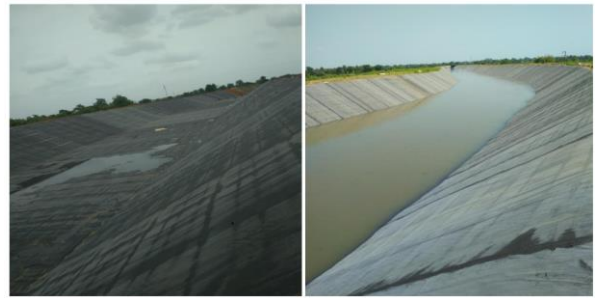
BGM Lining has been executed in 800 m of Pench Left Bank Canal in 2019. Before BGM lining heavy leakages were seen during irrigation and canal has been breached twice due to piping through canal. Burrowing animals made burrows through CC lining. However, since the BGM lining has been laid, there was no Burrow formation by Burrowing animals in the canal. No Physical damages like reduction in the thickness, change in colour and deterioration, deformation, adverse effect to BGM lining have been found even in high temperature variations.

Fig 4: Condition of Canal in July 2019

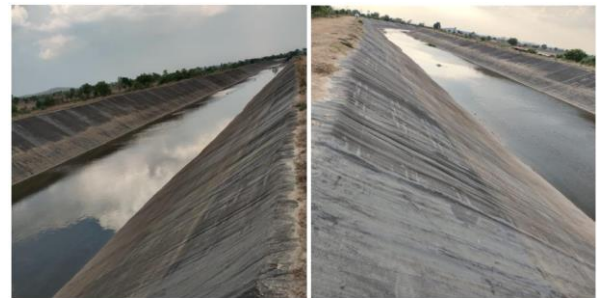
The fixity of BGM lining in the canal and its joints of Pench Left bank Canal are just as they were at the time of installation. Overall, the BGM Lining is still in good condition and performing satisfactorily even after about 4 years of completion. The total cost of BGM Lining work is lesser than that of cement concrete Lining as there is no requirement of CNS subgrade. It also requires lesser section because of lower value of Manning's Coefficient (N).

Fig 5: Condition of Canal in January, 2023
